Corrosion Evaluation and Mitigation of Bonded Post-Tensioning

VCS Engineering, Inc.

NATIONAL BRIDGE PRESERVATION CONFERENCE 2024
Innovation for Infrastructure Resiliency

Case History of 3 Bridge PT Evaluation

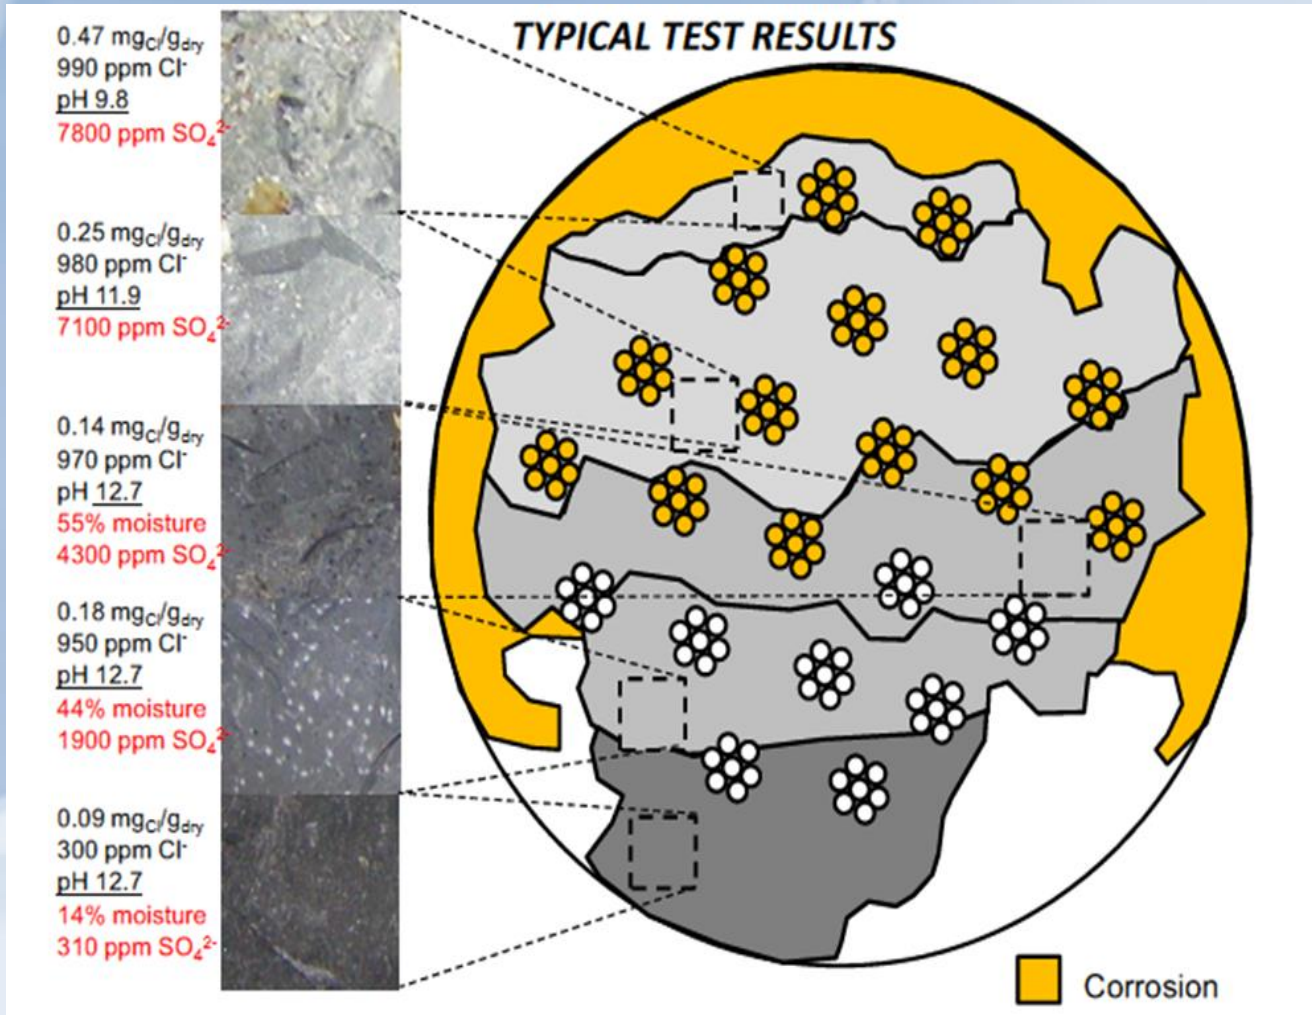
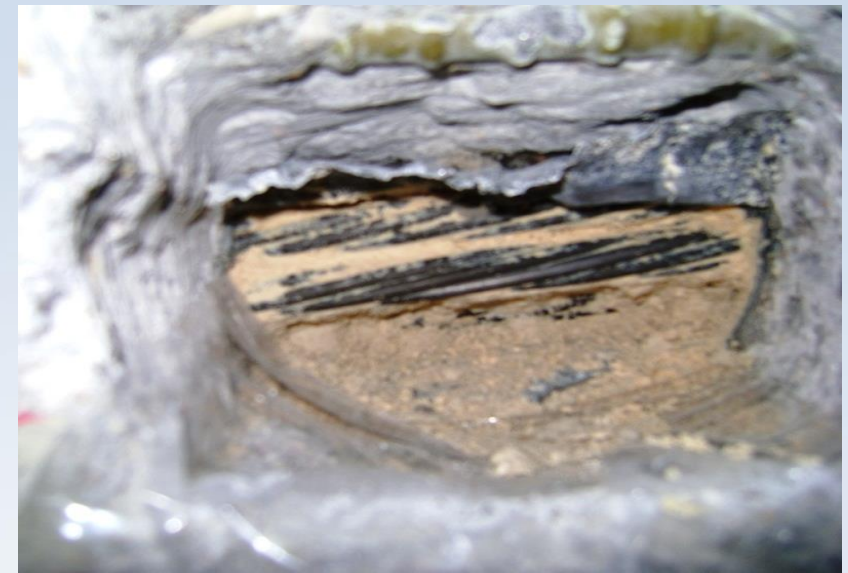
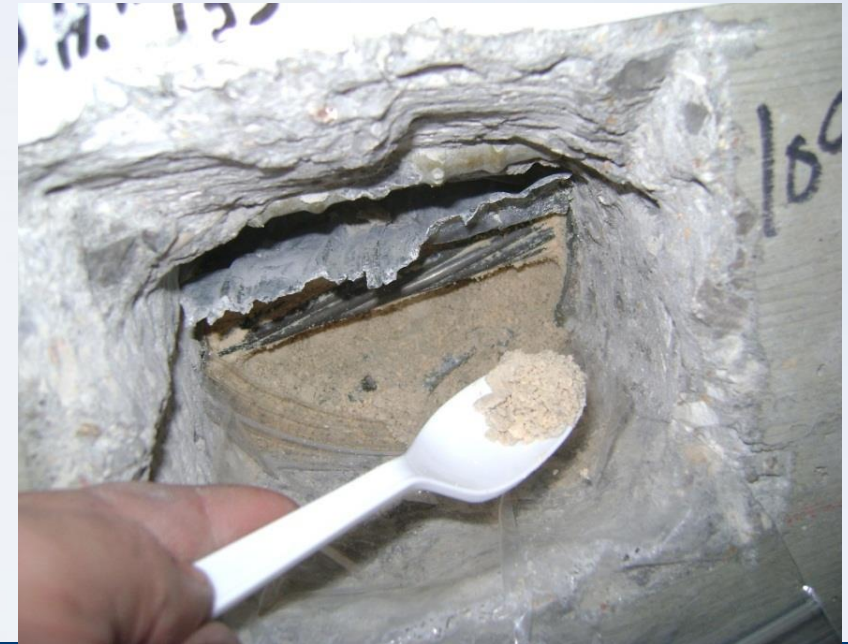
Defective Grout (Segregation)

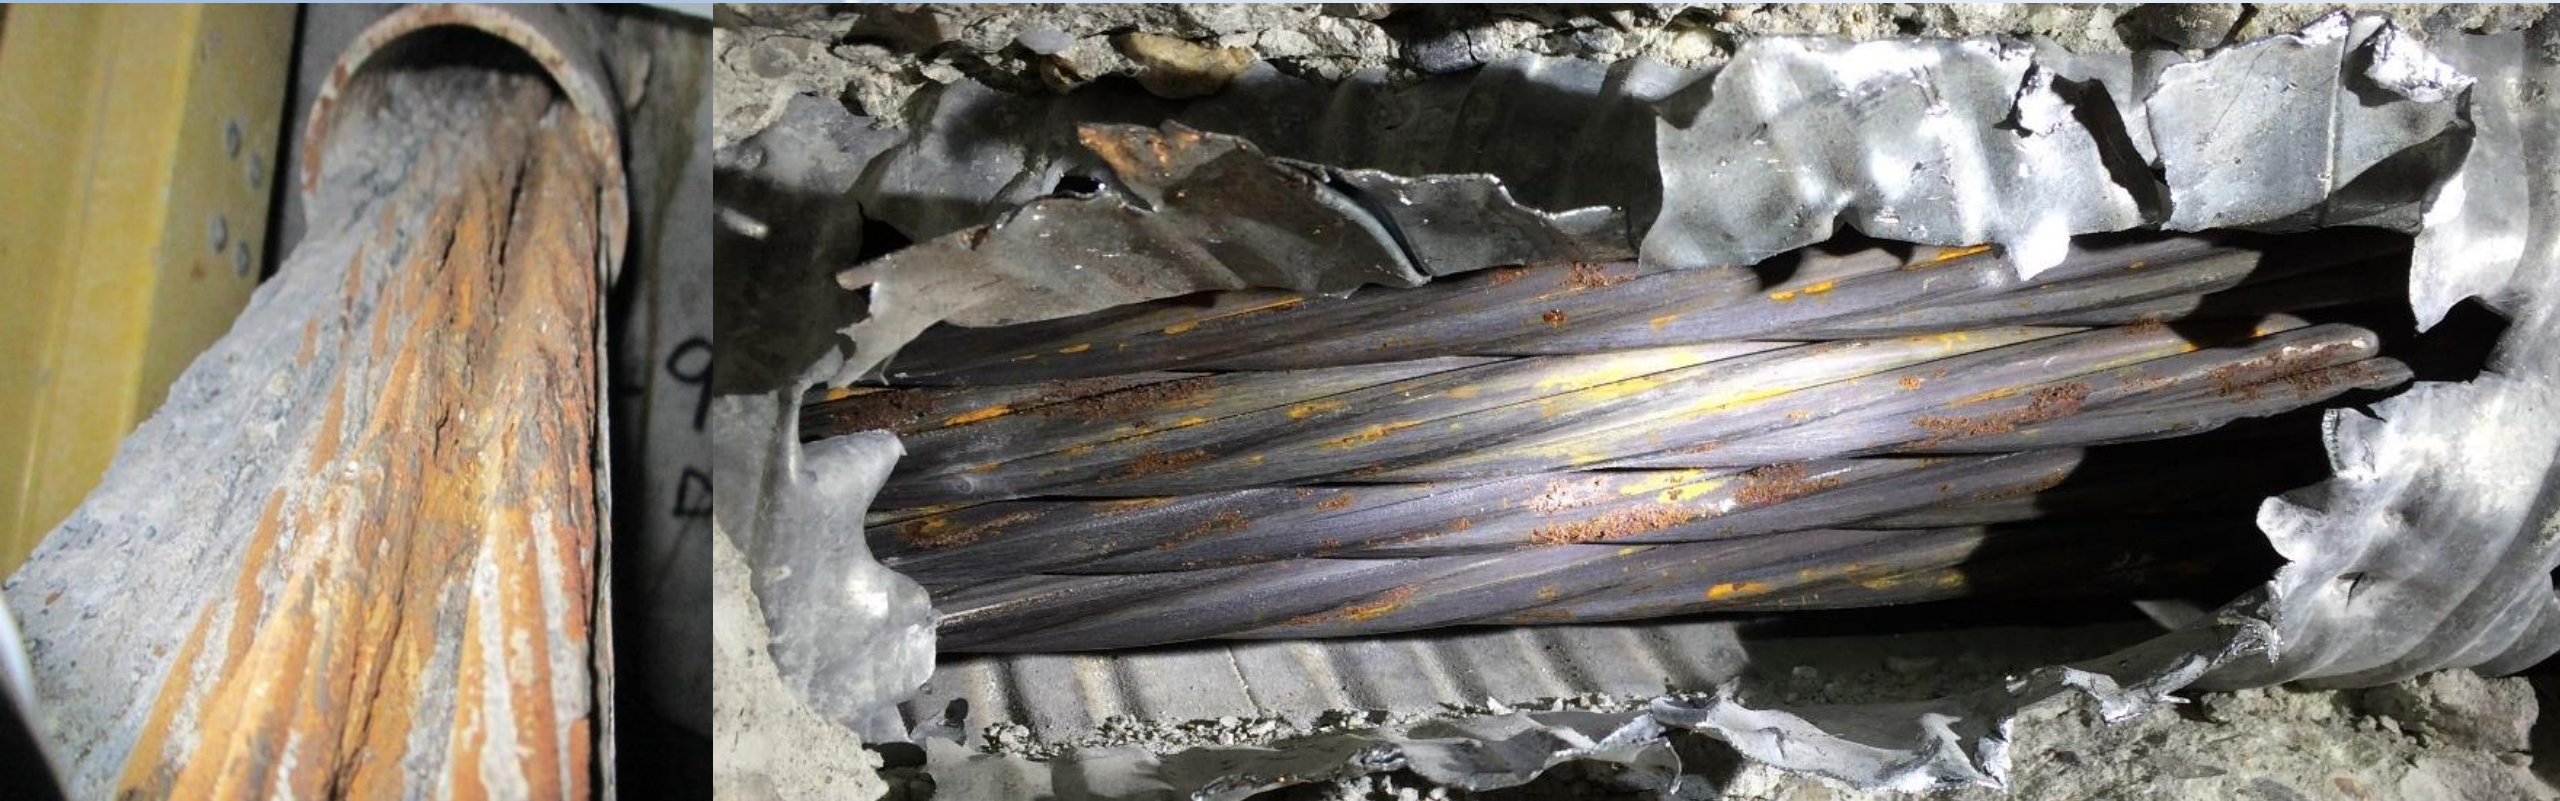
Grout Voids -Unprotected Strands

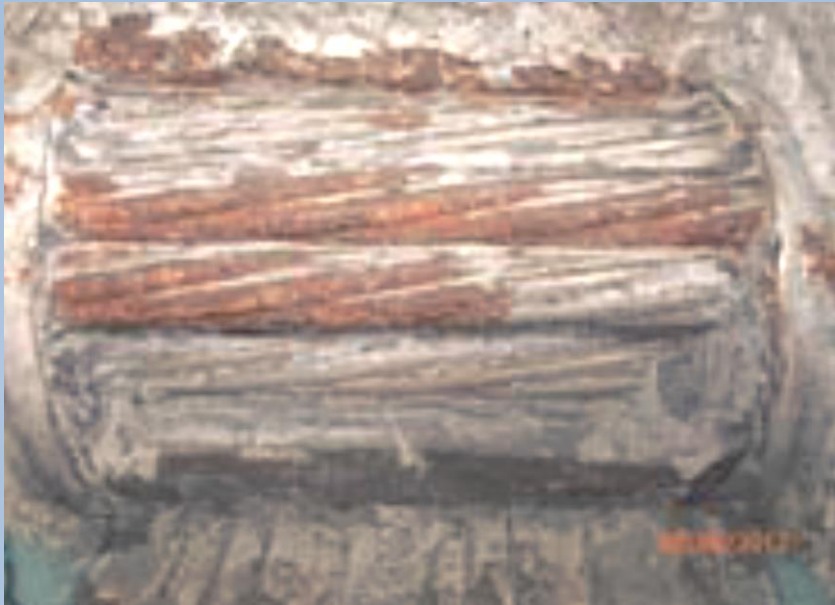
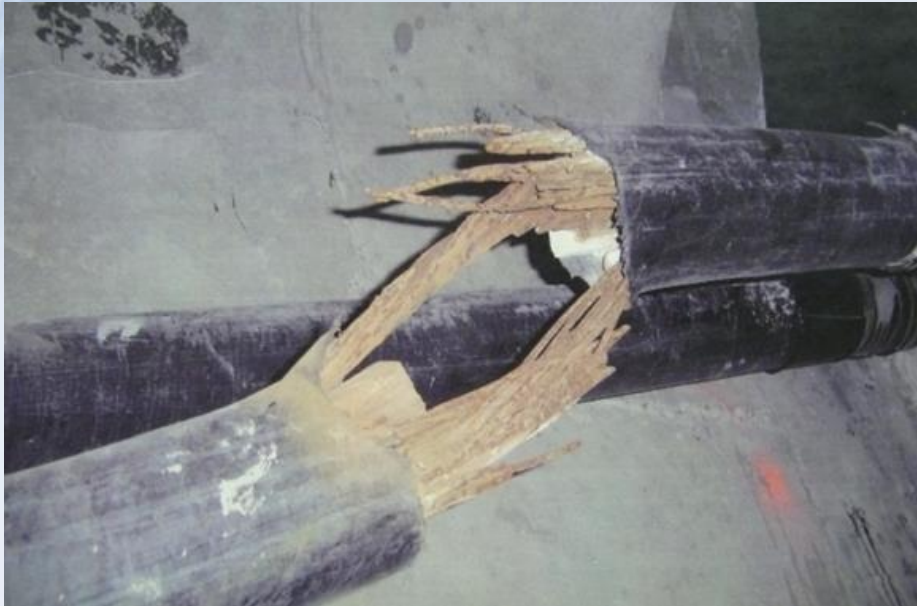
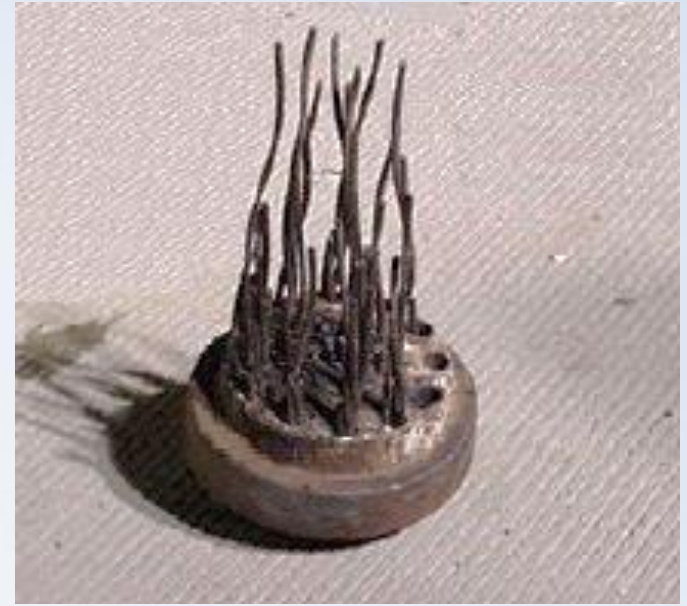
Corrosion

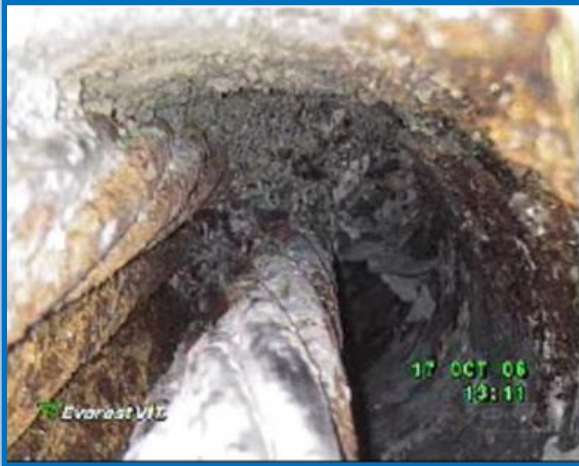
Void Bottom Corrosion on
Duct & Tendons

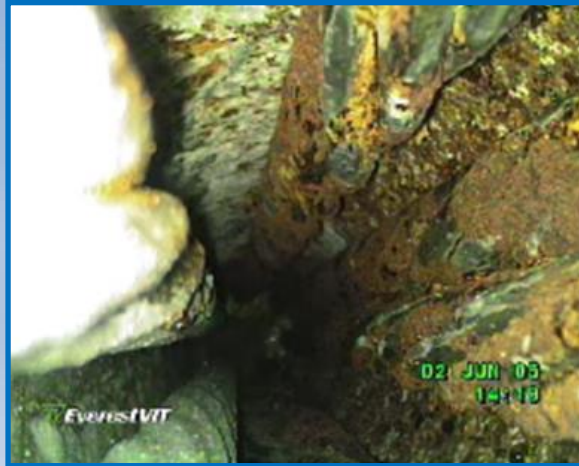
Corrosion on Duct &
Tendon

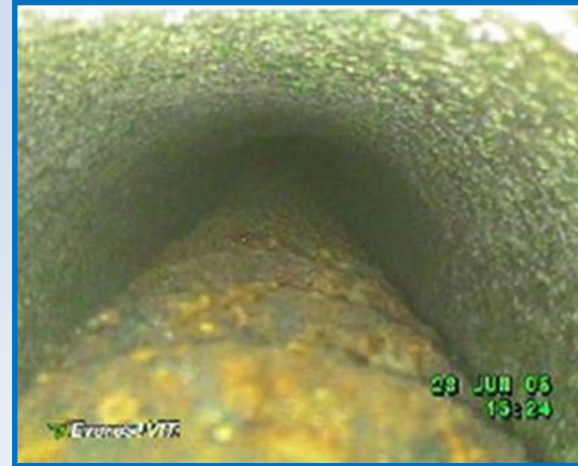
Void in Pier With Dywidag
Bar Instead of Tendons

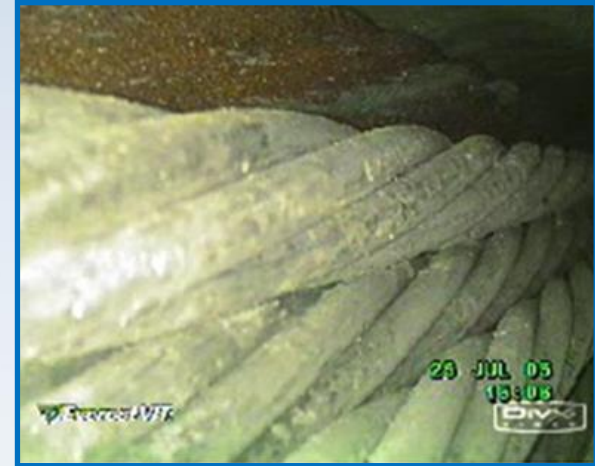
Corrosion on Duct

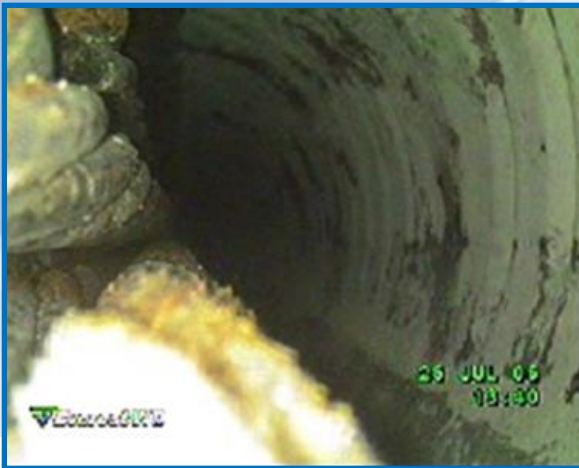
Void With Tendon
Corrosion

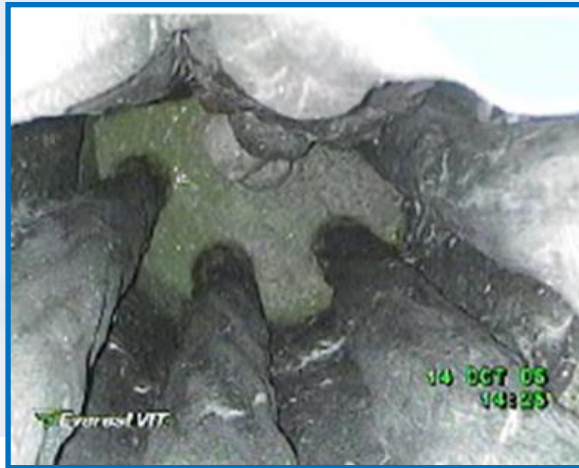
Anchor Plate, Tendons &
Duct are Grout Coated

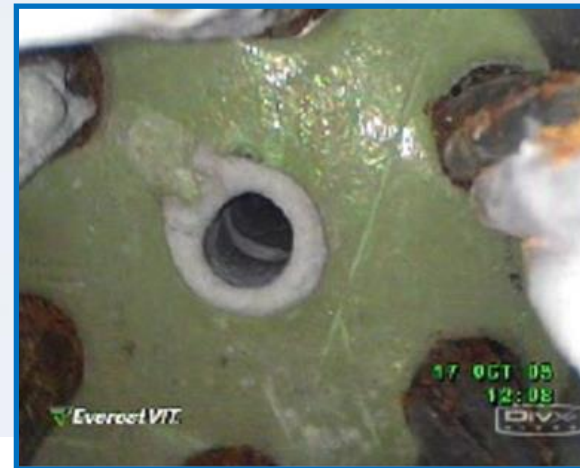
Anchor Close-Up, Top of
Tendons Show Corrosion

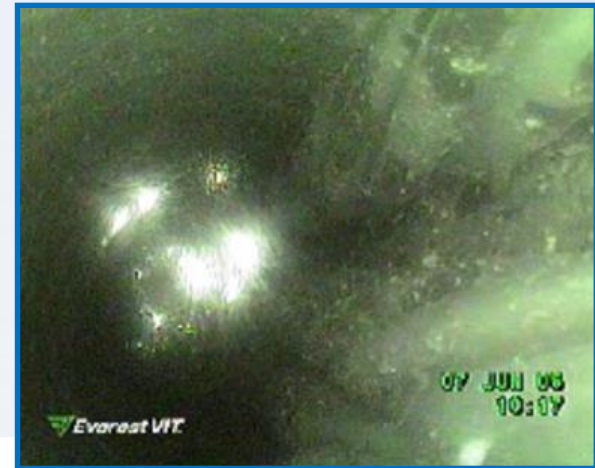
Tendon Found with
Standing Water Inside

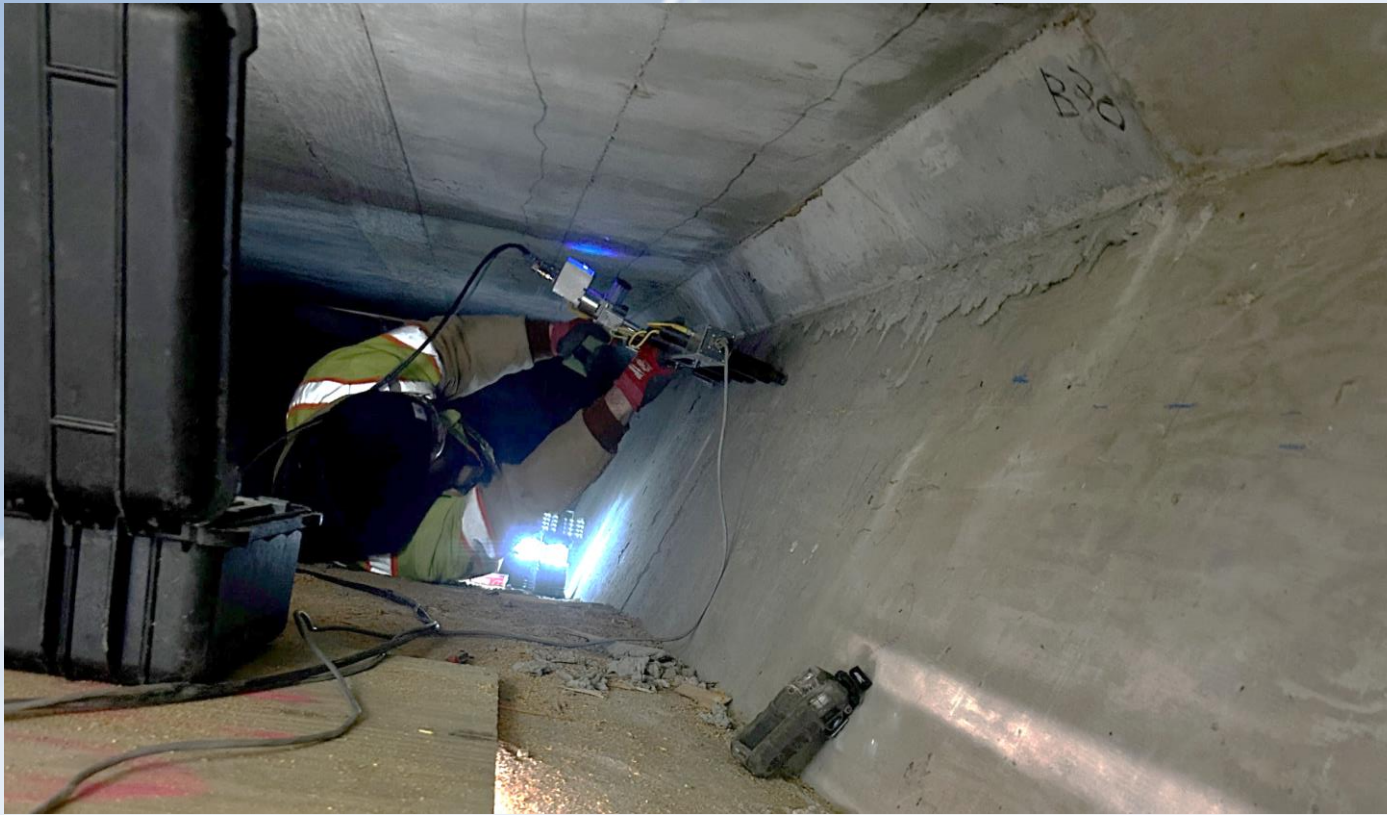
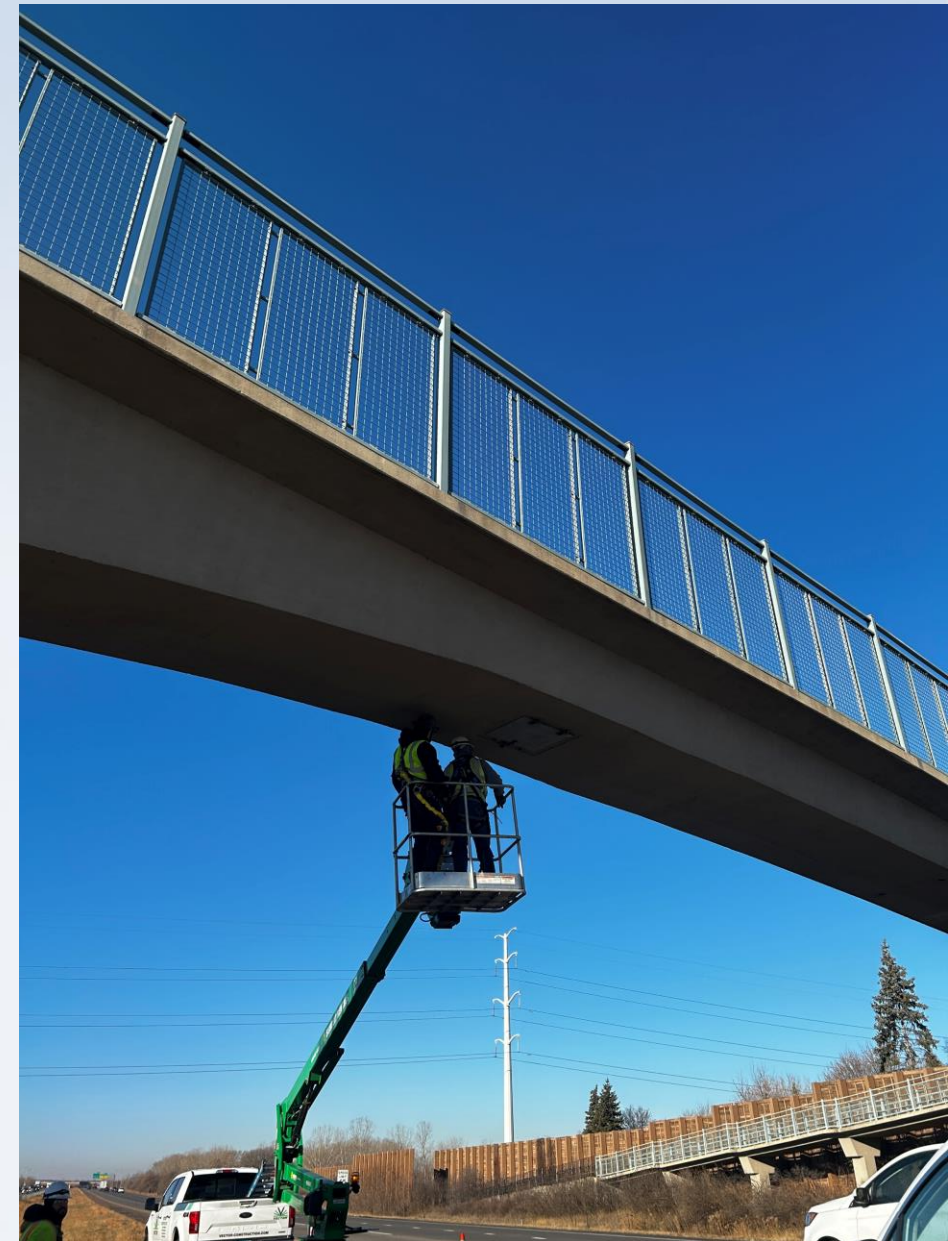
Pedestrian Bridge

- IE/PV identified the presence of lens voids and soft grout in one tendon

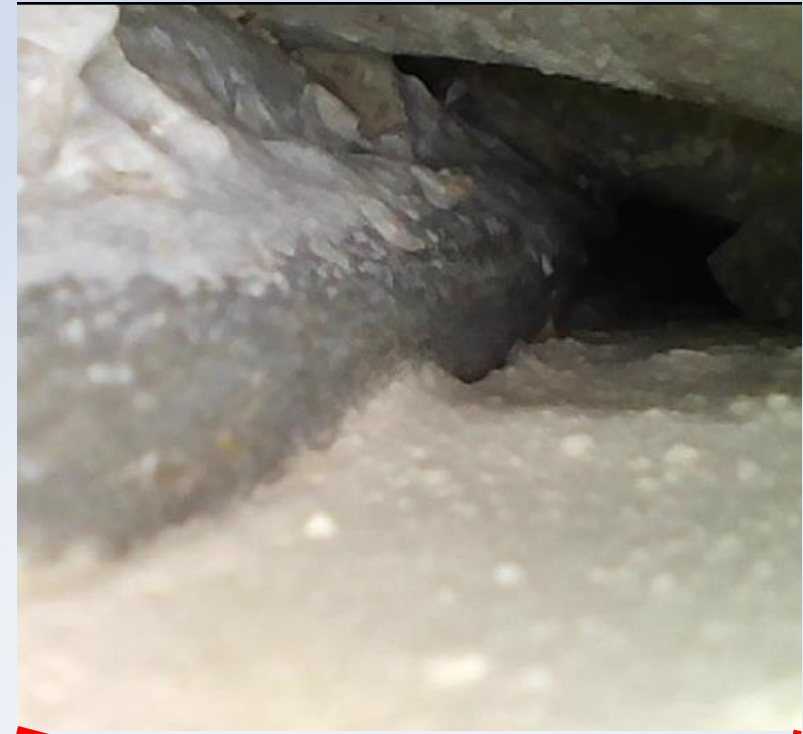
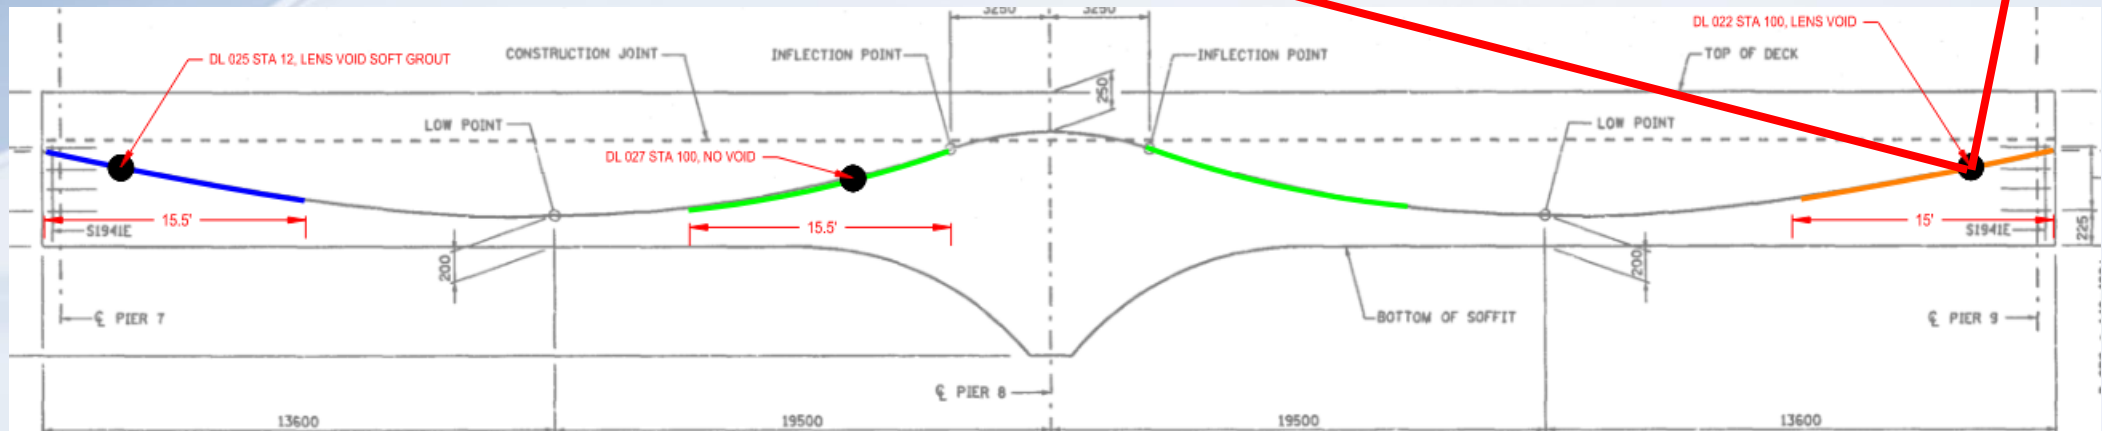
Pedestrian Bridge

- Defects identified in west girder

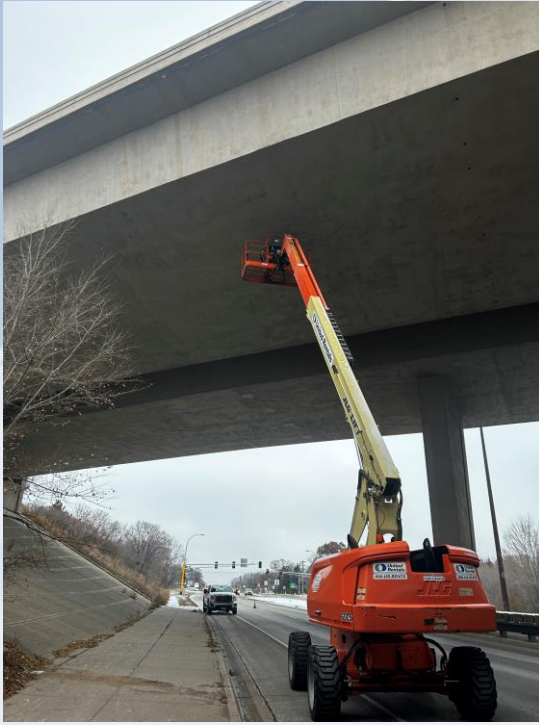
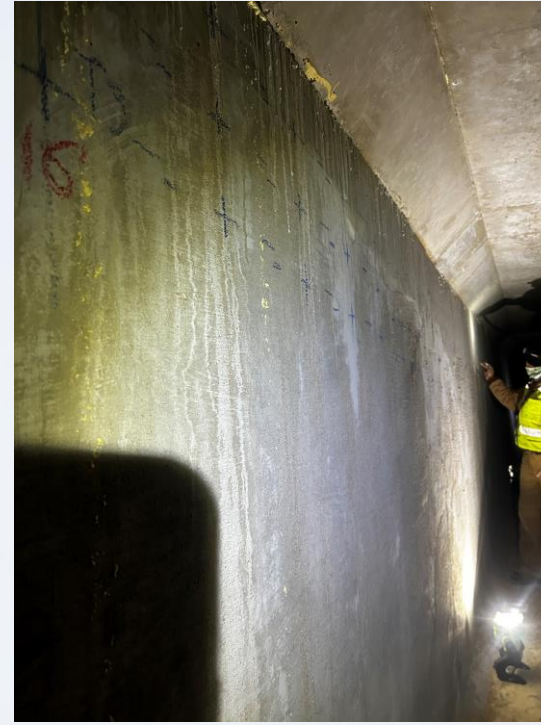
WB Bridge

- Previous inspections employed drilling in random locations to identify voided tendon ducts.
 - Some remedial grouting repairs
- VCS identified a large void that was approximately **48 feet** long

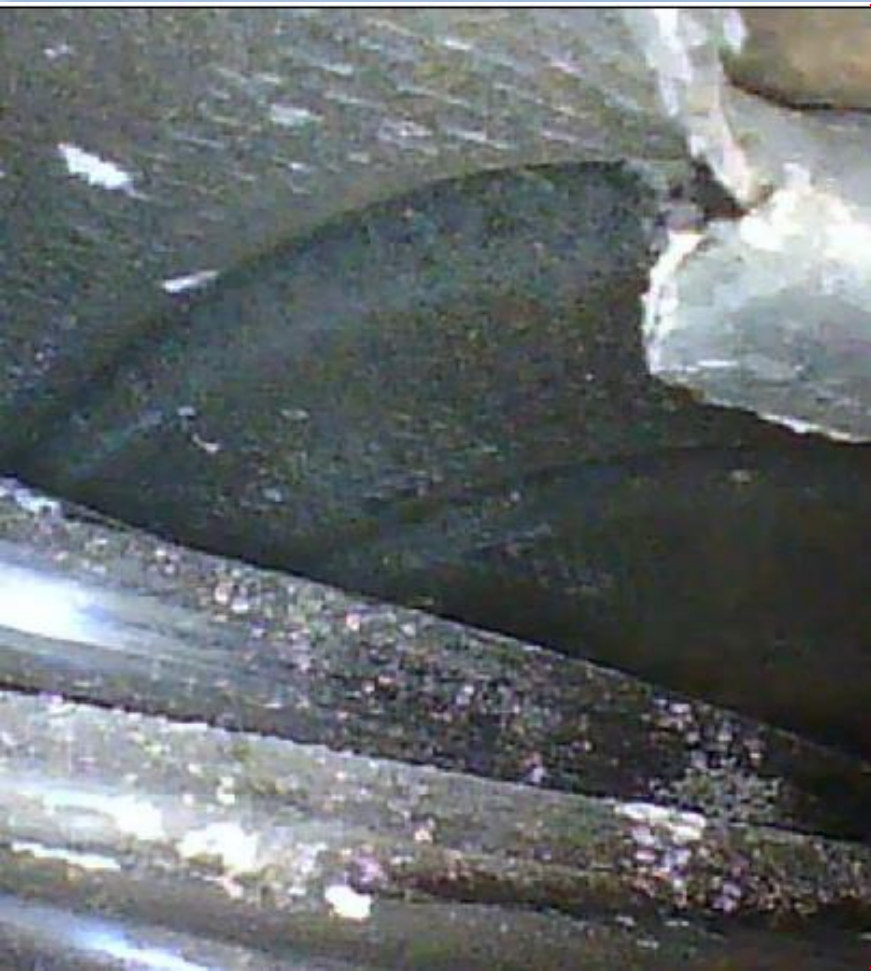
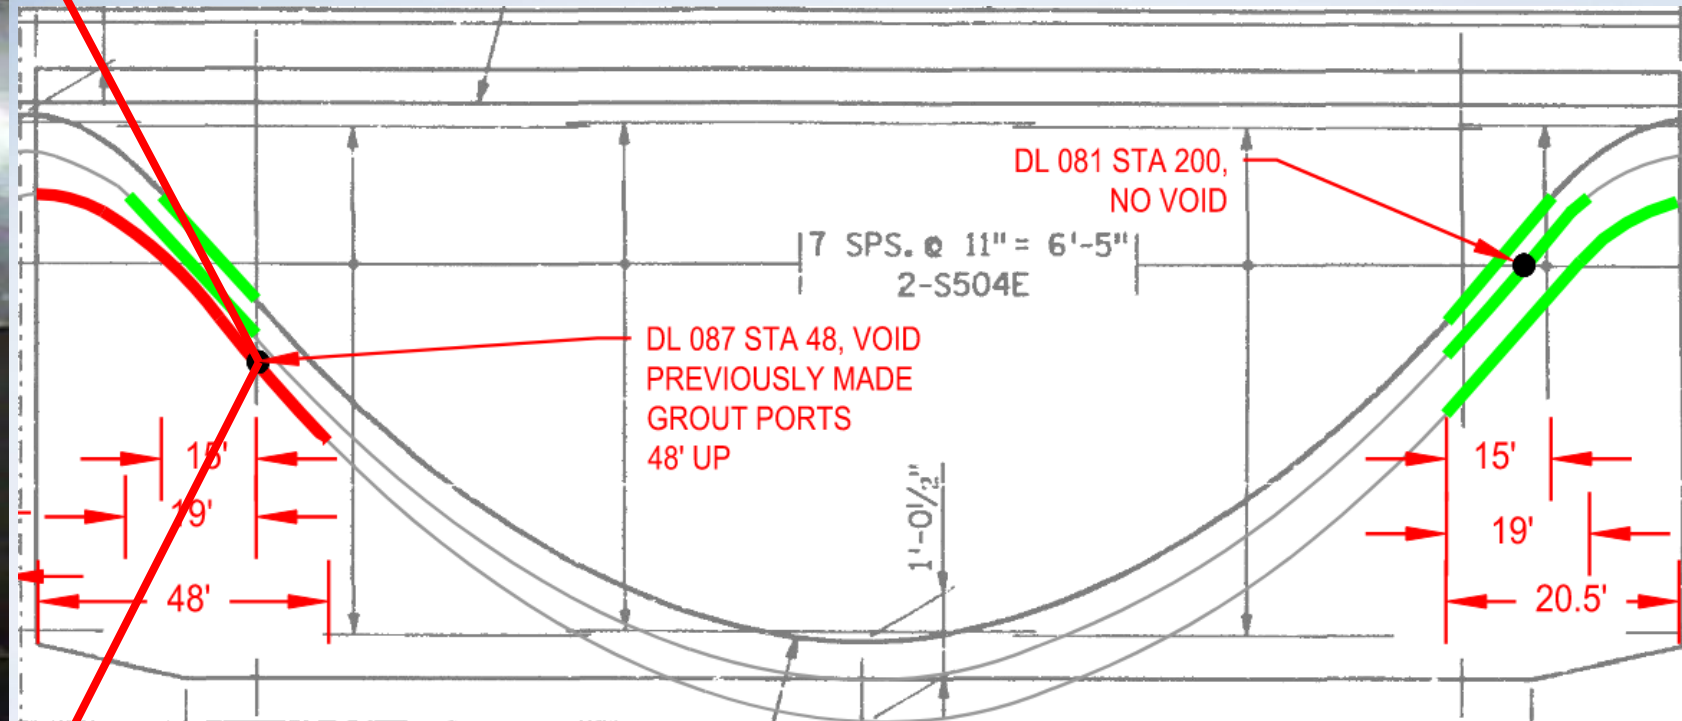
WB Bridge

- Largest identified void of 48 feet

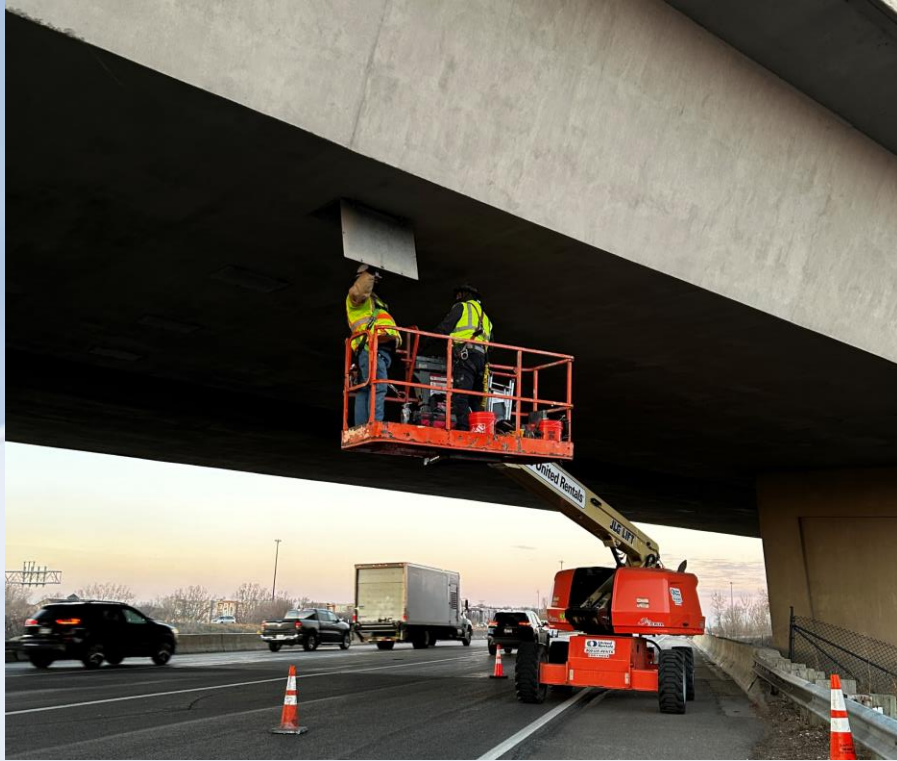
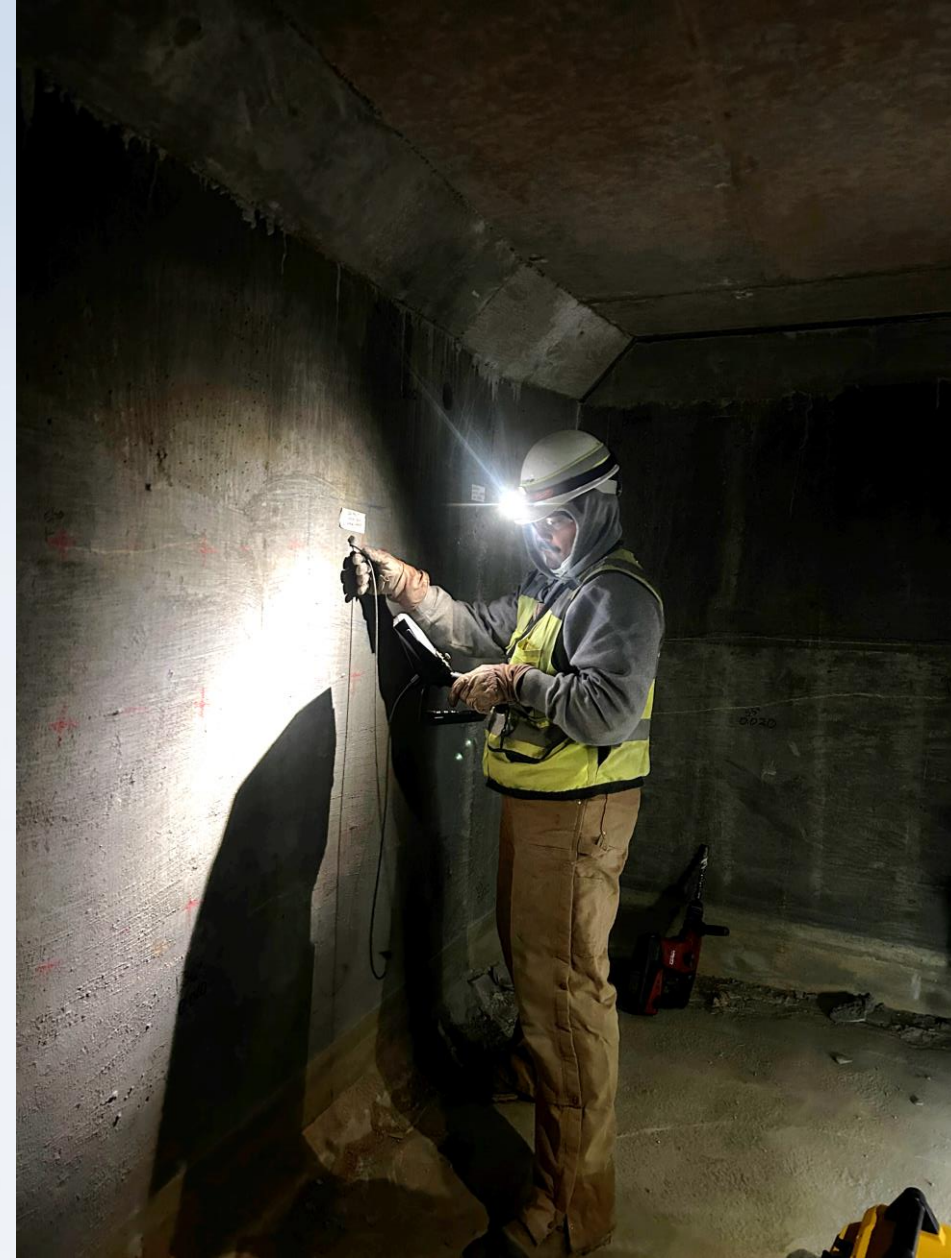
EB Bridge

- Previous inspections by random drilling
 - No remedial grouting in the past
- Largest void identified over **20 feet** long

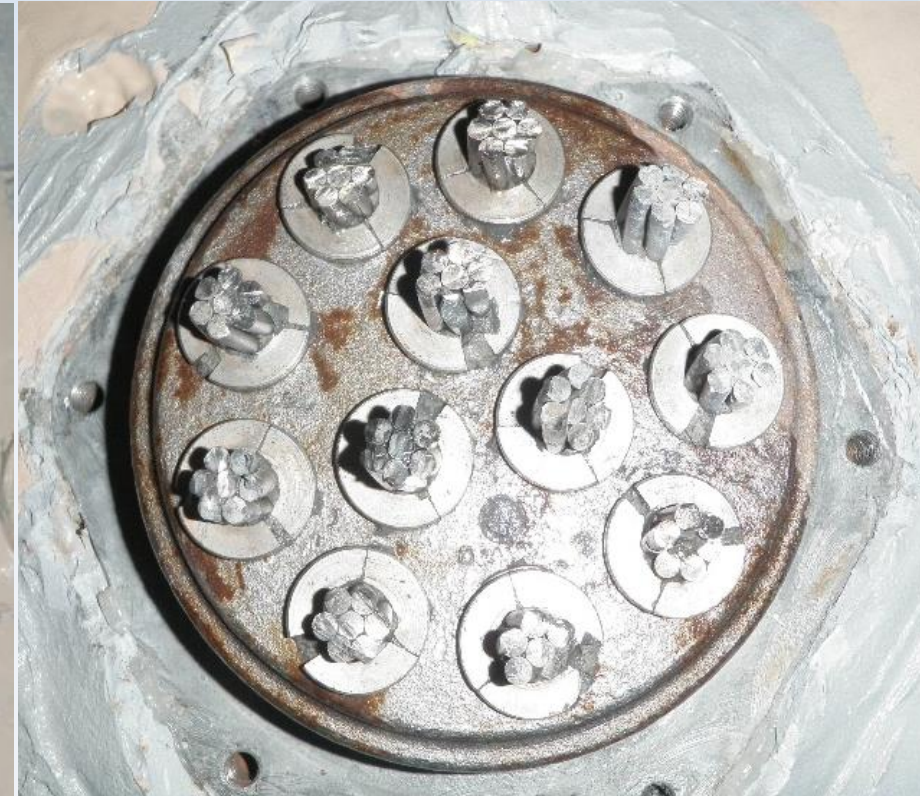
Exposed Strands
after Grout Removal

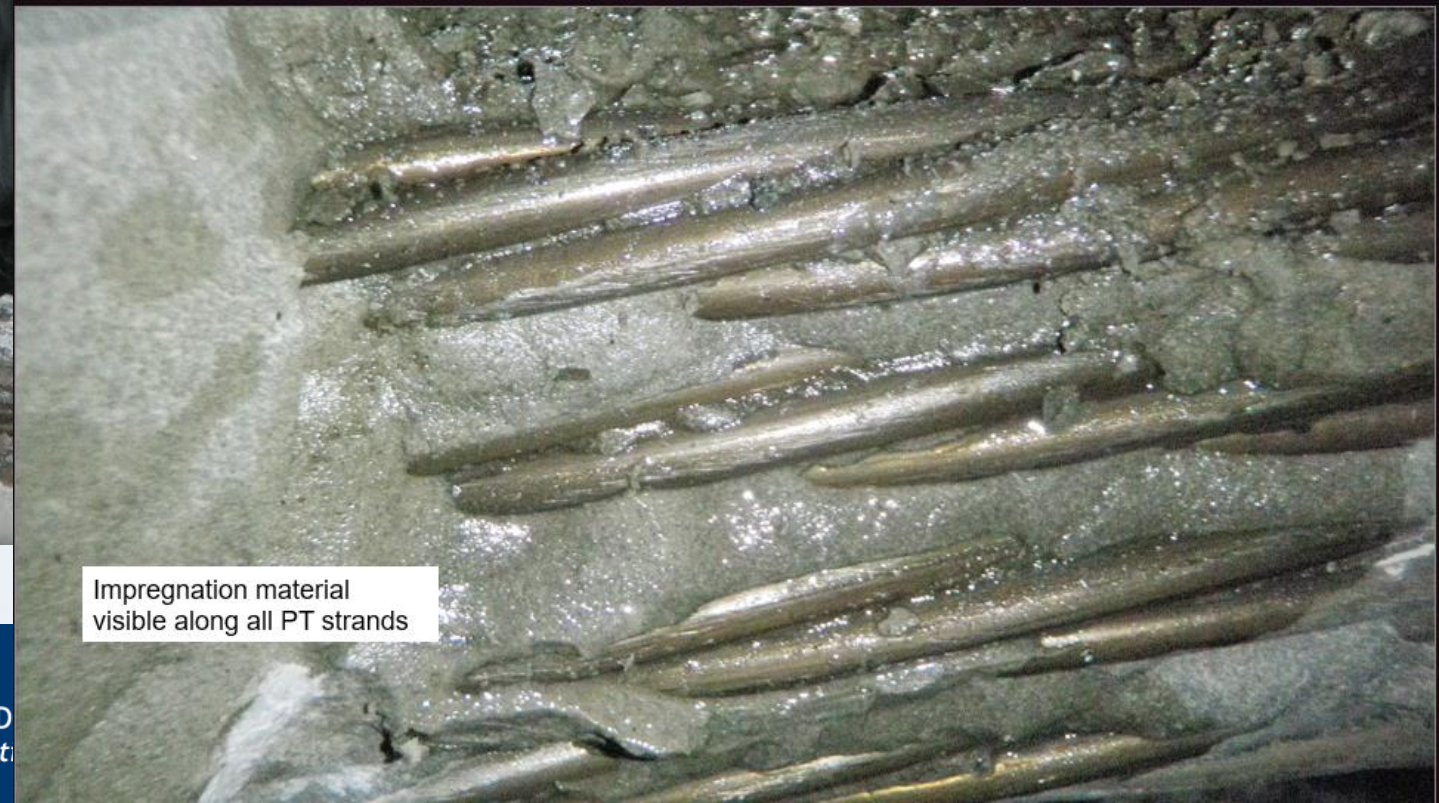
Impregnation material visible along all PT strands
