How Amish Buggy Bridge Deck Damage Turned into a Multidistrict Bridge Deck Maintenance and Repair Program

PennDOT Route 741 Bridge Repair with Fibrecrete

2024 National Bridge Preservation Partnership Conference

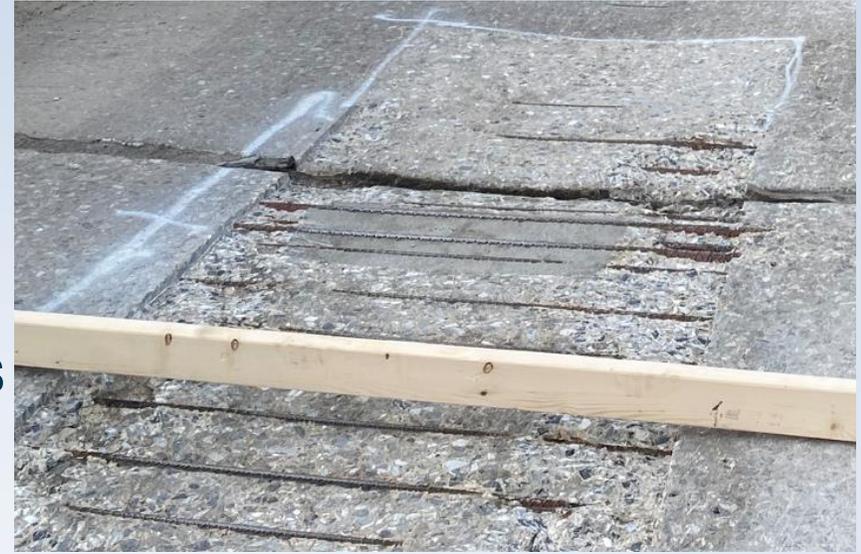
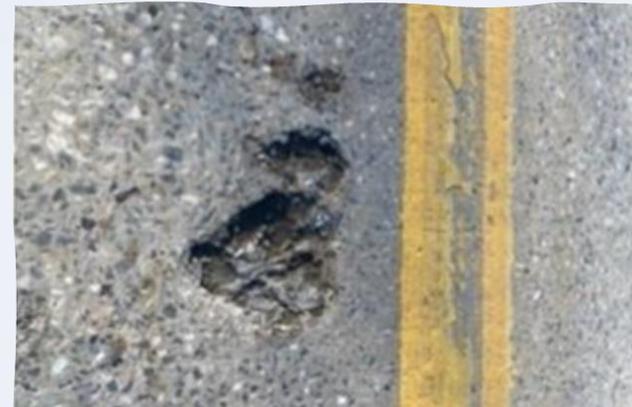
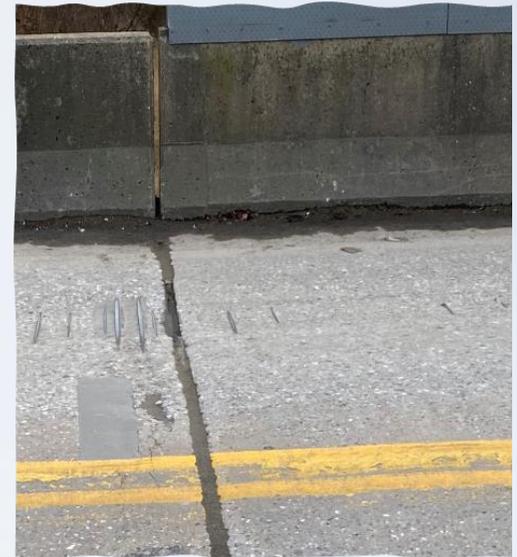
Summary

- Bridge has major rutting due to horse hooves and buggy wheels
- Bridge has exposed rebar
- Bridge has several spalled areas
- Bridge has open expansion joint

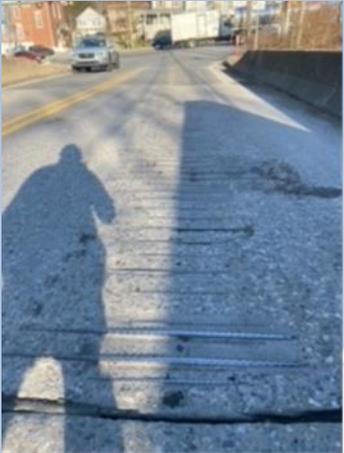
Before

Review of Rutted Area

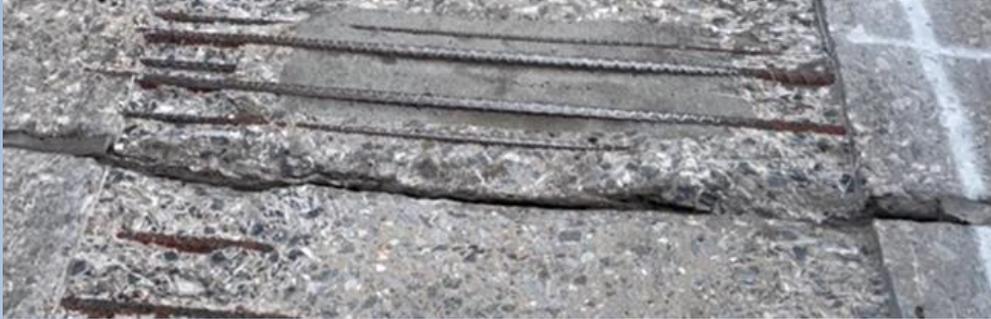
Before

Review of Expansion Joint

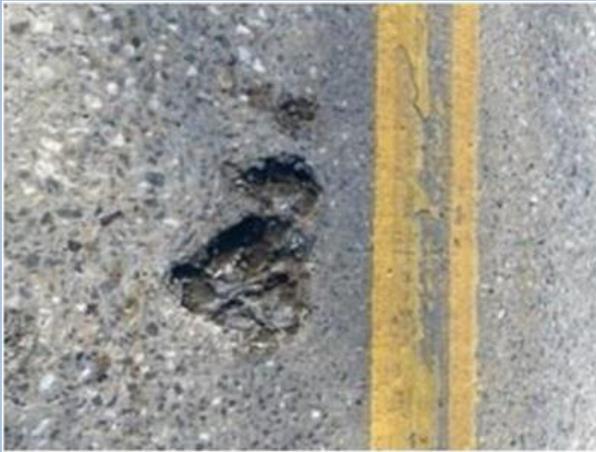
Before

Review of Spall

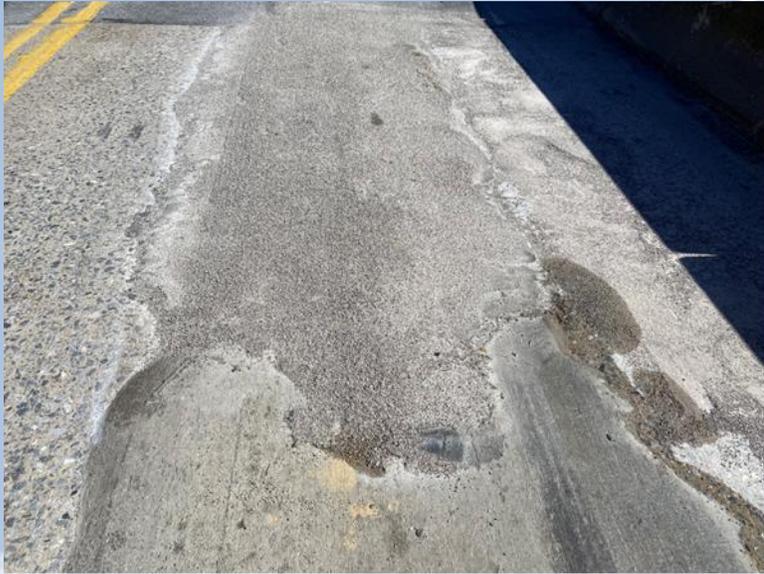
Where has this gone from the demo? PennDOT crews completed repairs on this bridge.
