Corrosion Evaluation and Mitigation of Bonded Post-Tensioning

VCS Engineering, Inc.

NATIONAL BRIDGE PRESERVATION CONFERENCE 2024
Innovation for Infrastructure Resiliency

Case History of 3 Bridge PT Evaluation

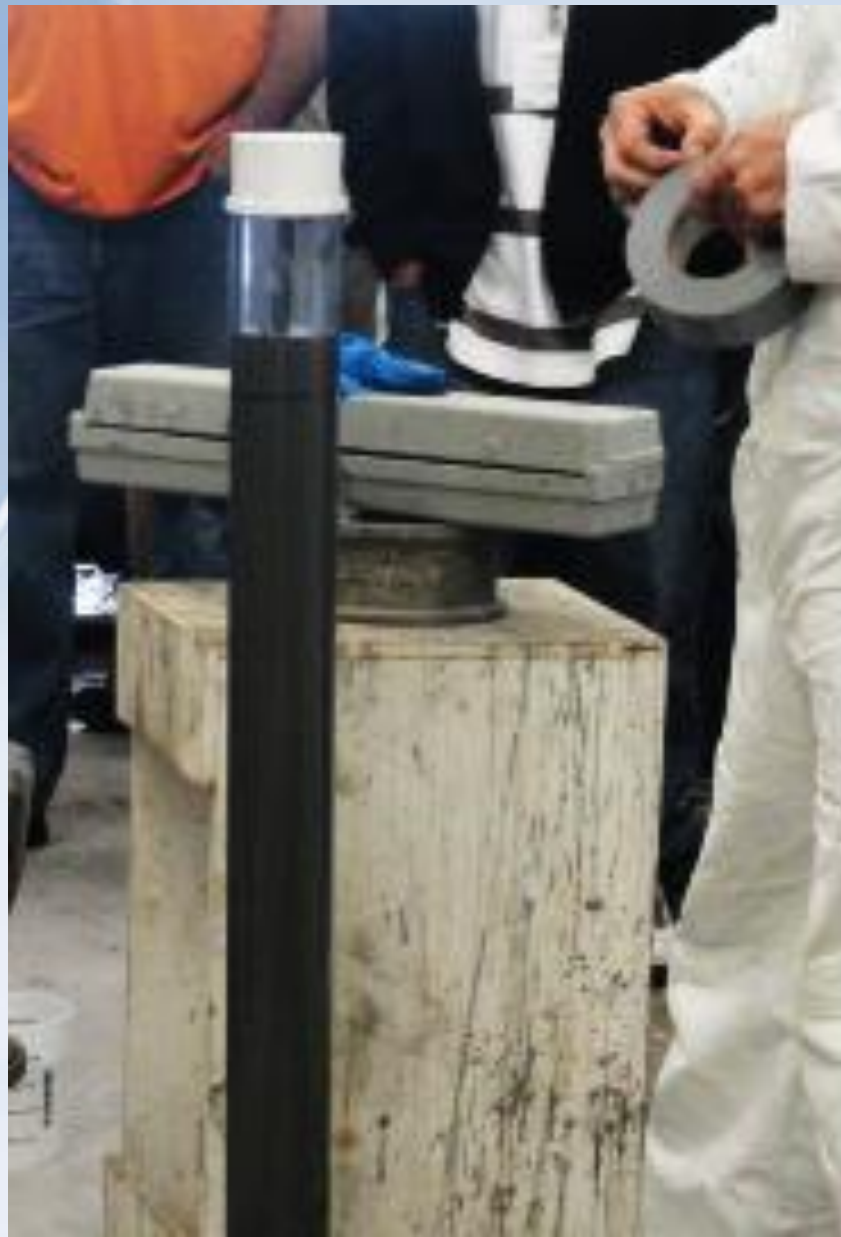
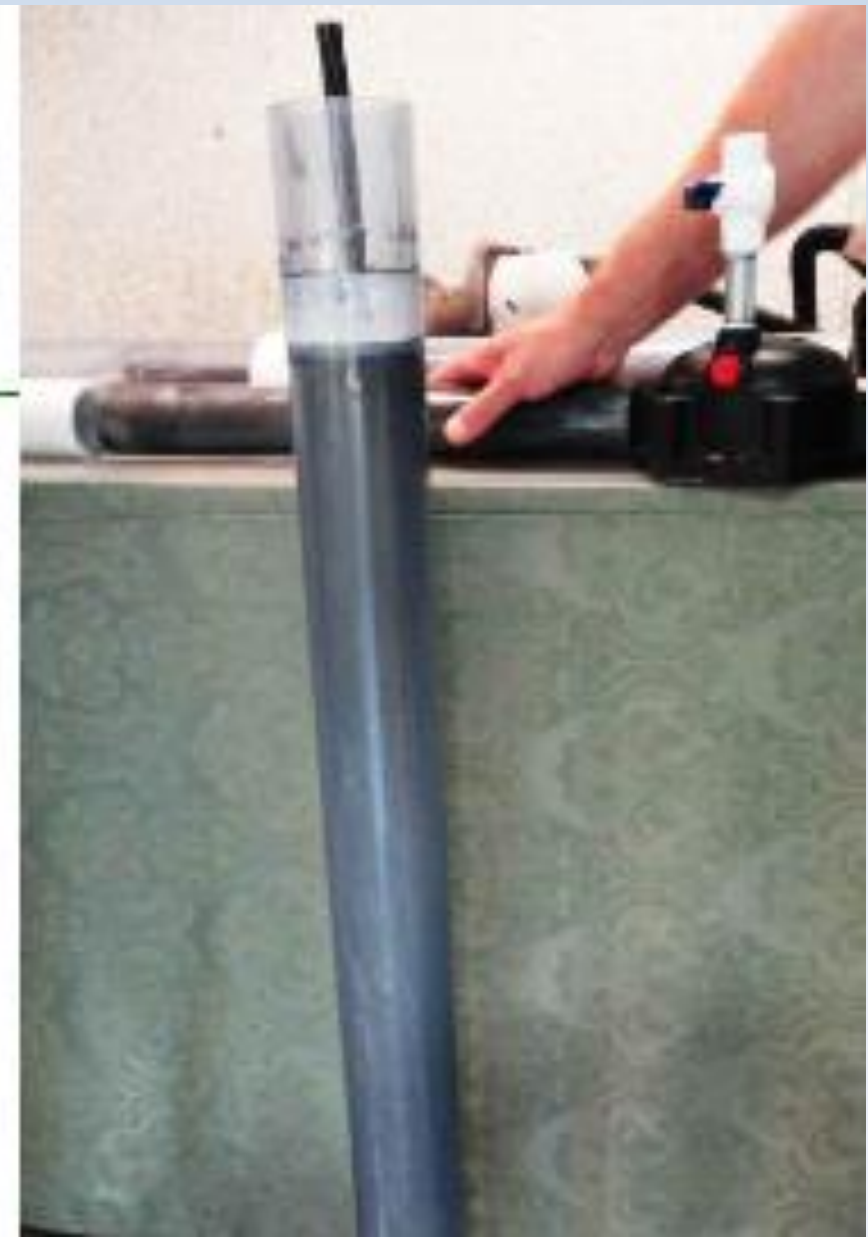
Bleed Test

Wick-induced bleed test by
American Segmental Bridge
Institute (April 2012)

Portland cement
grout ~ 4% bleeding after
24 hours of
grout operation.

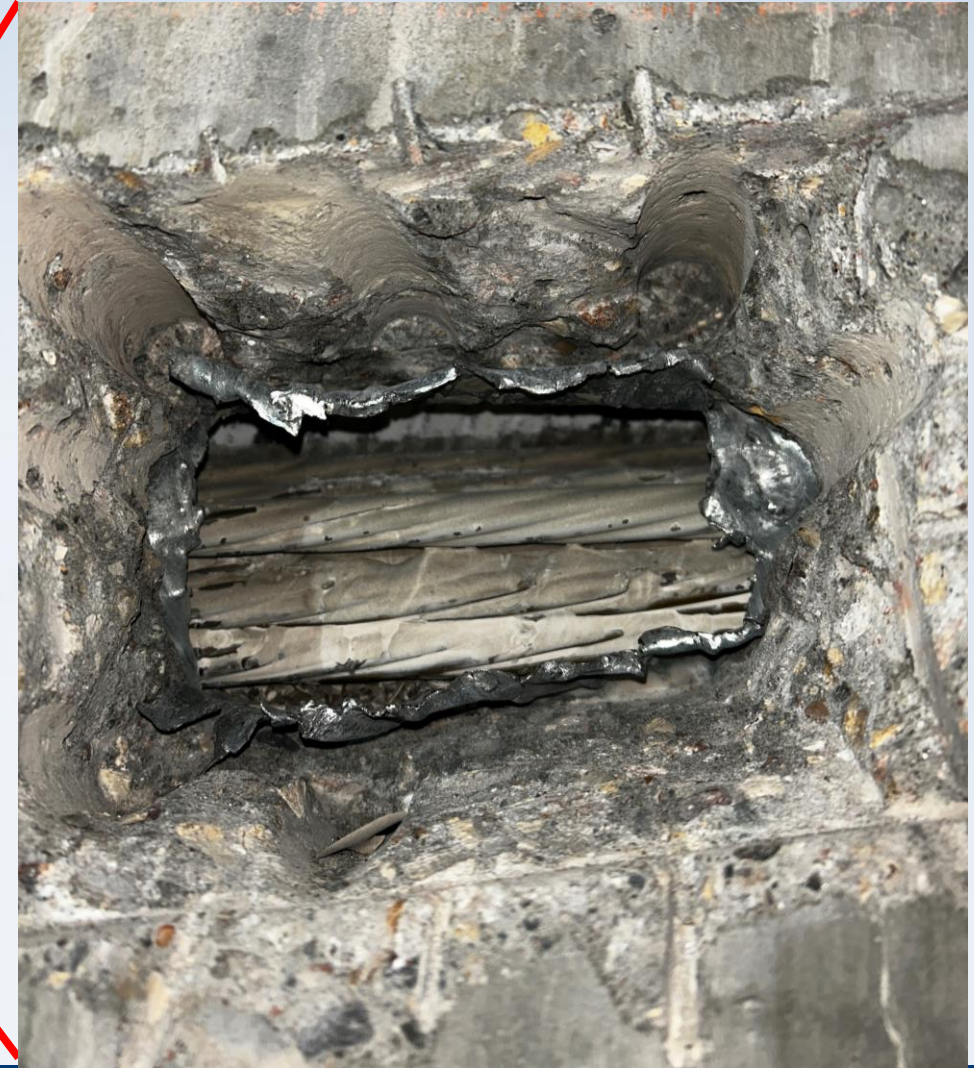
EB Bridge

- Previous inspections by random drilling
 - No remedial grouting in the past
- Largest void identified over **20 feet** long

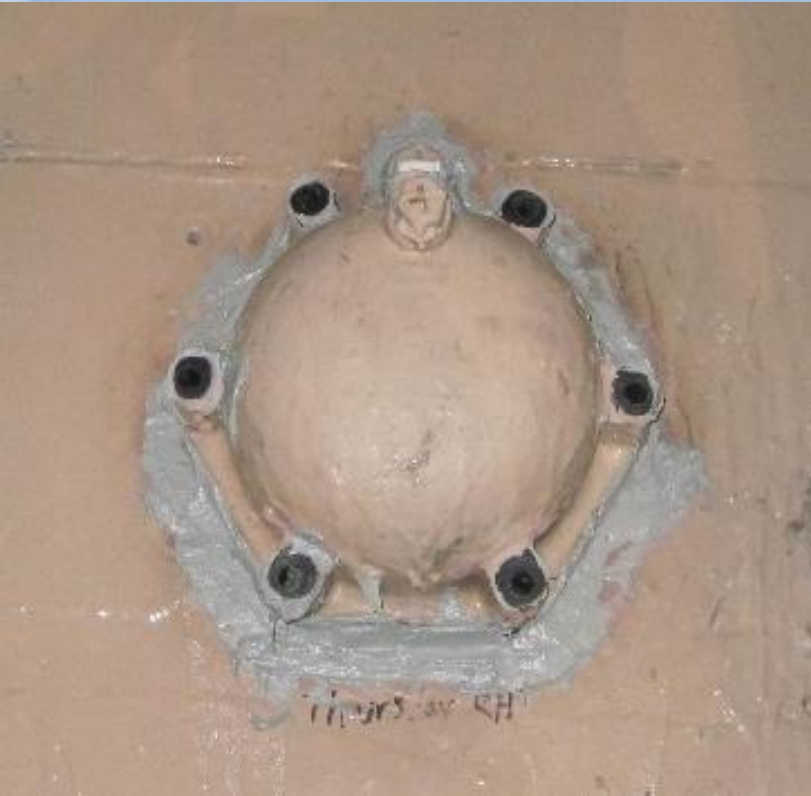
Original Anchor Cap

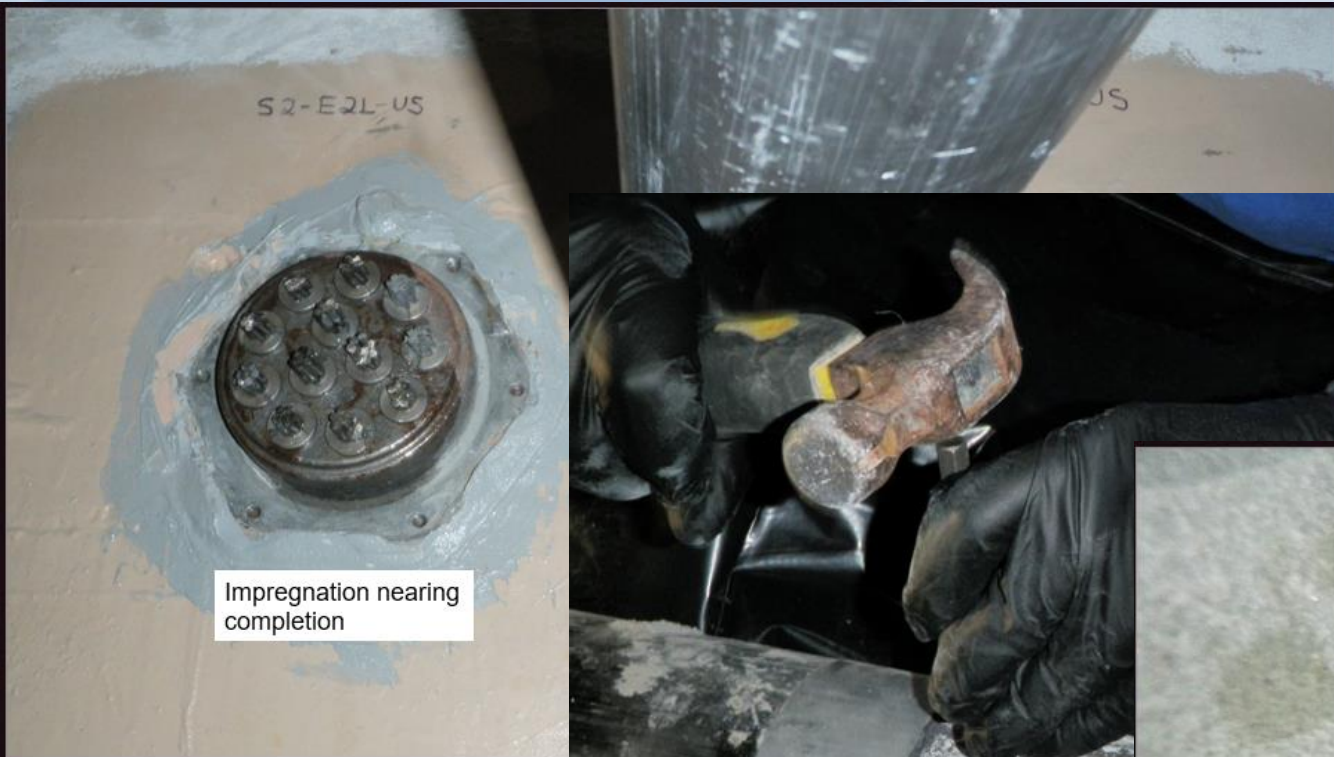
Impregnation Material Appear at Far End

Impregnation nearing completion

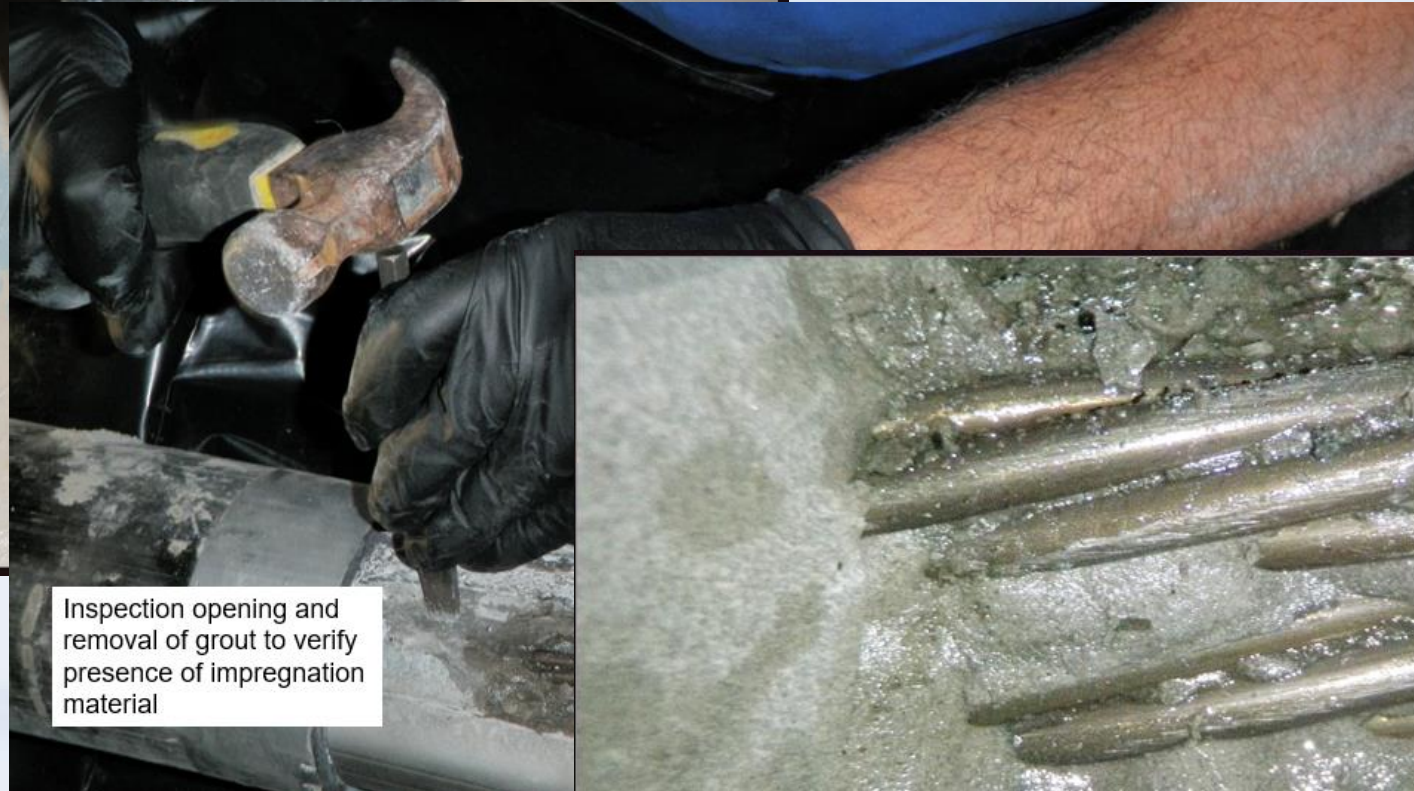
Inspection opening and removal of grout to verify presence of impregnation material

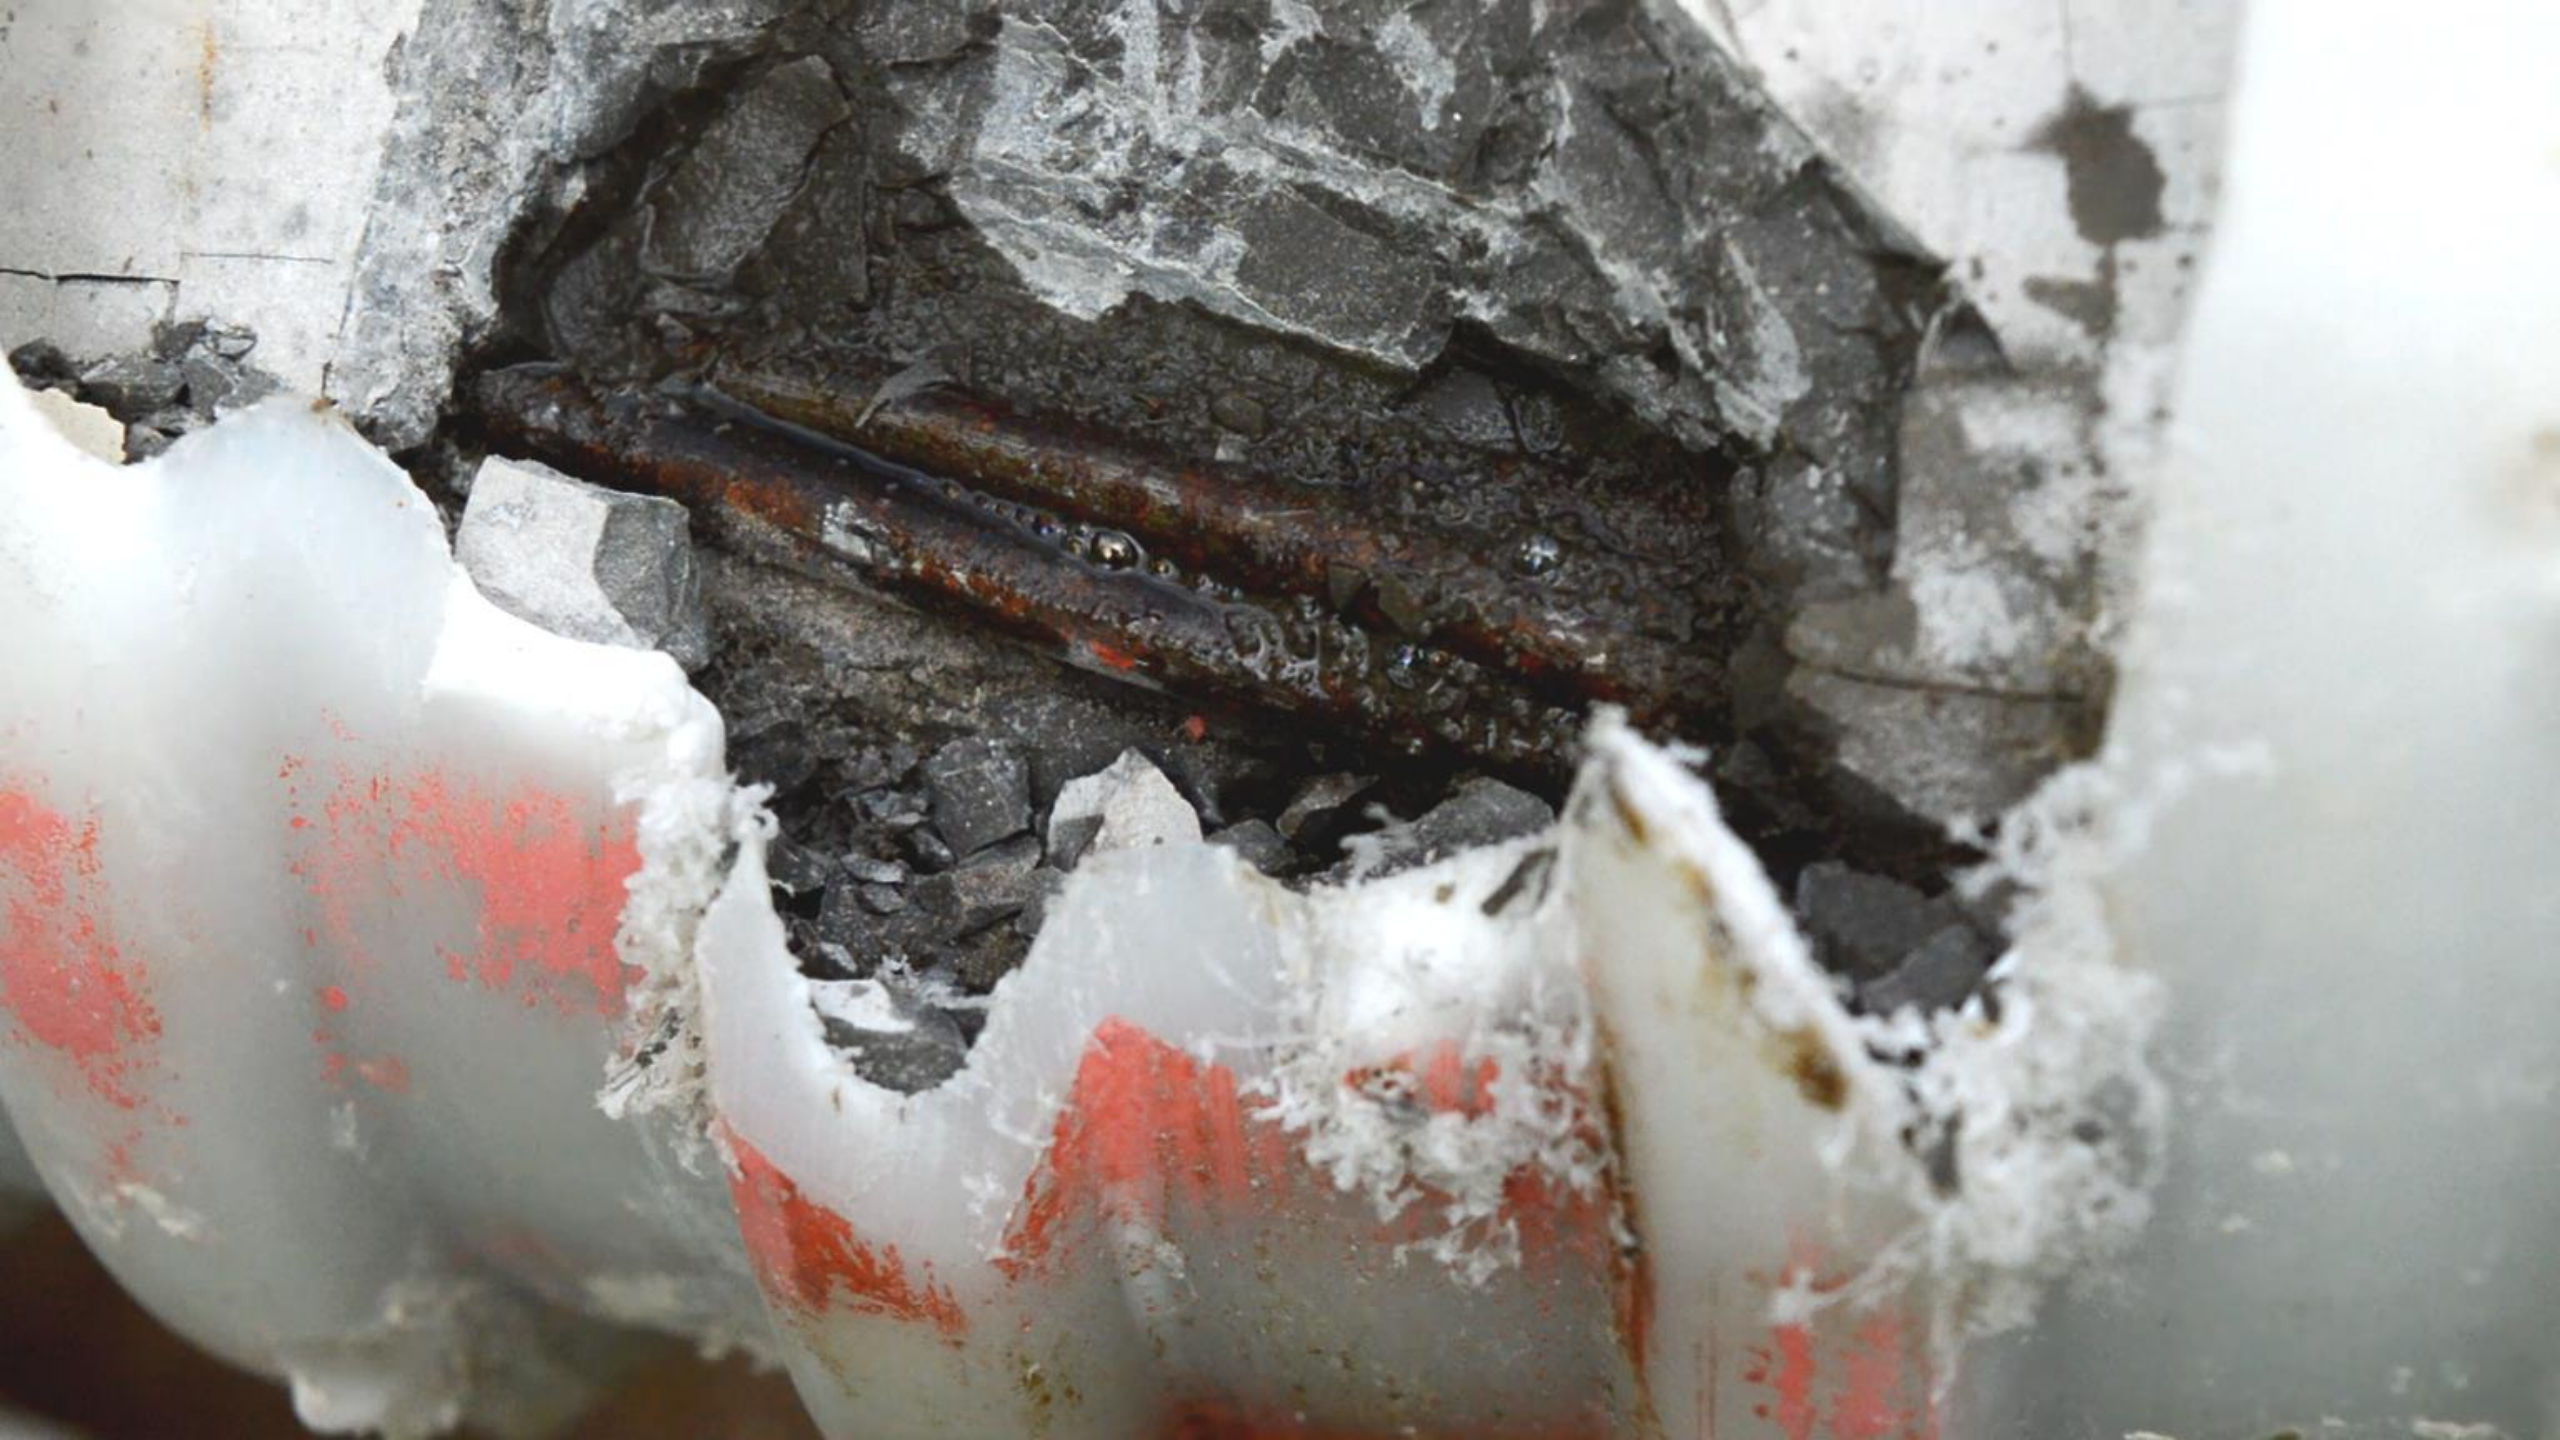
Impregnation material visible along all PT strands
